CITY OF ROCKS NATIONAL RESERVE
Plan and Environmental Assessment

RESTROOM IMPROVEMENTS

December 10, 2002

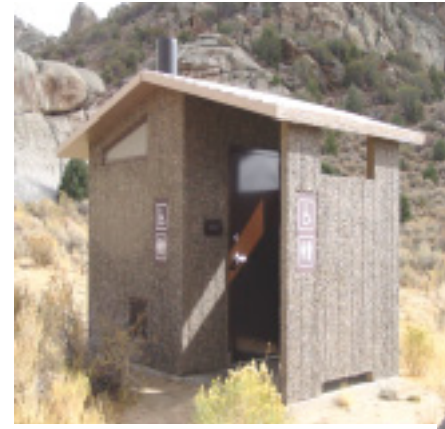
Gunnison-style toilet example

Materials required to place the Gunnison style toilet and construct the parking area include 40 feet of 16- inch diameter culvert, 127 cubic yards of fill and 63 cubic yards of road gravel. Total ground disturbance required for the vault is 2’6” deep by 9’ wide by 17’ long. Total area to be impacted by fill material is 40’ along the existing road to 51’ south of the road at the farthest point. Plans include the placement of a culvert, 127 cubic yards of fill and 63 cubic yards of gravel over fill. This development will prevent the uncontained disposal of human waste, and provide support facilities for compatible recreational activities. The proposed action is the environmentally preferred action and would not constitute impairment to park resources.

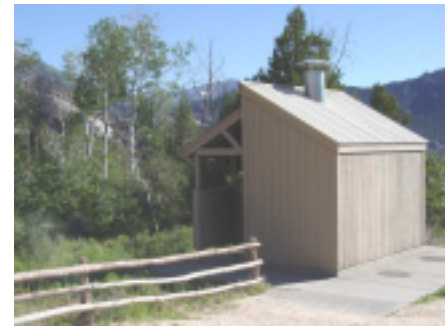
Existing Bath Rock vault toilet

One of the first vault toilets installed by CIRO was located at Bath Rock, the primary meeting place for campers and day-users. Since its installation in 1989, the parking area, trailheads, wayside exhibits and campsites have been developed or improved. The architecture of this vault no longer matches the newer models. It has endured heavy snows, vandals and significant public use. It is no longer situated at the proper height, given the upgraded parking surface developed in 1996. This unit currently serves most of the day-use visitors, and a considerable number of campers, especially sites 46-58.

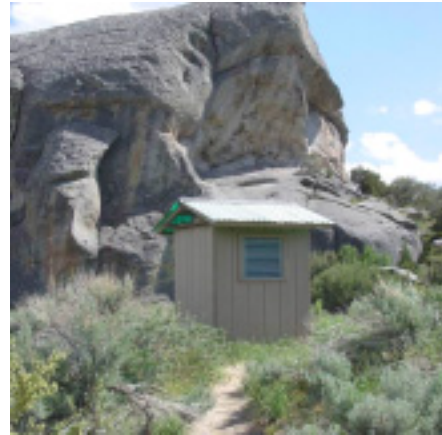
Elephant Rock vault toilet
planned for removal

Elephant Rock is one of the more popular rocks with climbers as it provides exceptional sport climbs near camping and parking. A small wooden, non-ADA compliant, vault toilet was placed at this location in the late 1980's. Now that a modern vault toilet is located nearby, this unit no longer meets a critical need. It is located in an area that is only visible to climbers around Elephant Rock, and does not serve other users.

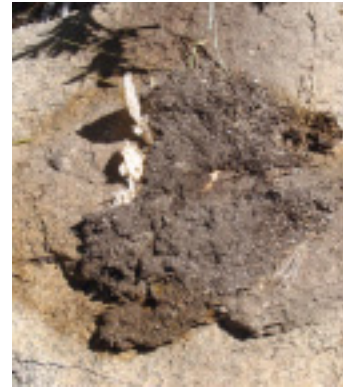
Uncontained human waste at Finger Rock campsite

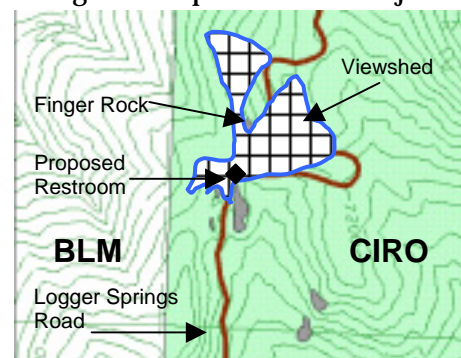
Extent of viewshed from proposed Vault

4. Perhaps the greatest potential concern is that the vault toilet would encroach on the scenic viewshed. Considering the planned location (tucked into the curve of the road and obscured by Almo Quartzite outcrops and Mountain Mahogany, the encroachment is minimal and only seen from a bend in the road above Finger Rock for a short distance. See viewshed map on page 4 and also in appendix with photo points (page 20).

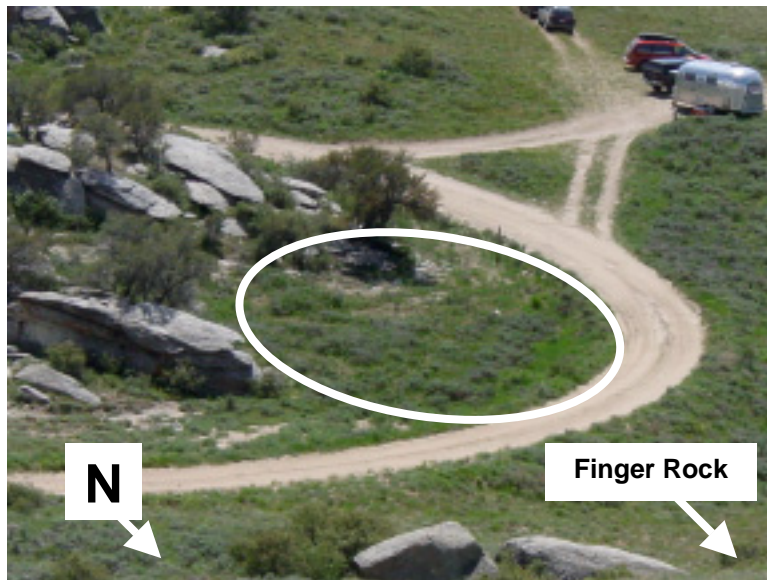
Finger Rock proposed impact area for vault toilet and parking area

The reserve proposes to add one vault toilet (to serve campsites 75-78) located south of the granite spire known as “Finger Rock” in the southern bend of the Logger Springs Road, specifically SW¼, SW¼, S23, T15S, R23E of the Almo, Idaho Quadrangle.

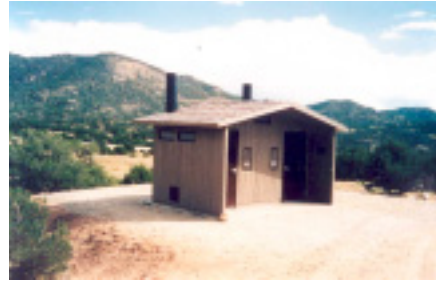
Tioga-style CXT pre-cast double vault toilet
Exposed Aggregate not shown

The reserve proposes to replace the existing framed structure with one Tioga-style CXT pre-cast double vault toilet with Exposed Aggregate texture, located on the northeast side of the Bath Rock parking area, specifically SE¼, NW¼, S36, T15S, R23E of the Almo, Idaho Quadrangle.

138 cubic yards of fill gravel is required to place the Tioga style toilet, bringing the walk-in surface level to parking lot grade.

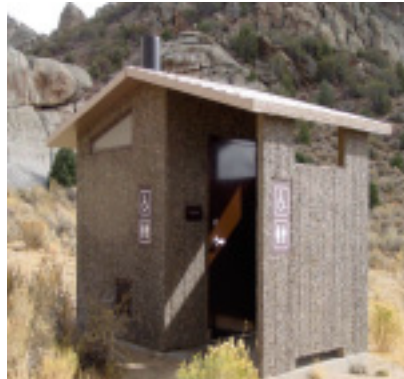
Gunnison CXT Precast Concrete

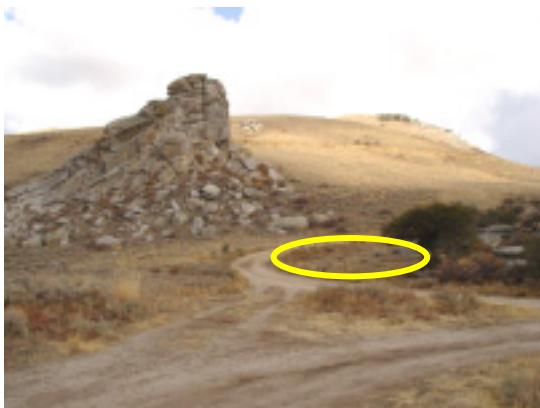
View NE from Campsite 77
Area of Impact circled

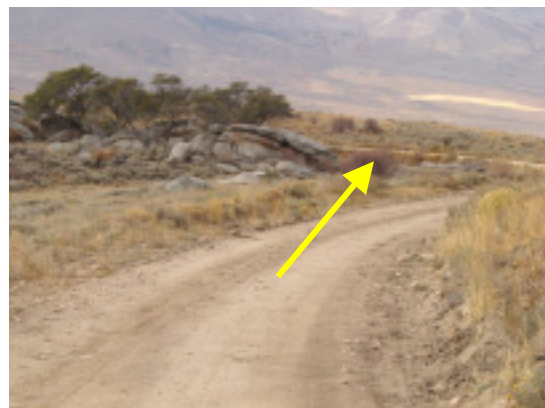
View W from Logger Springs Road
Area of Impact noted

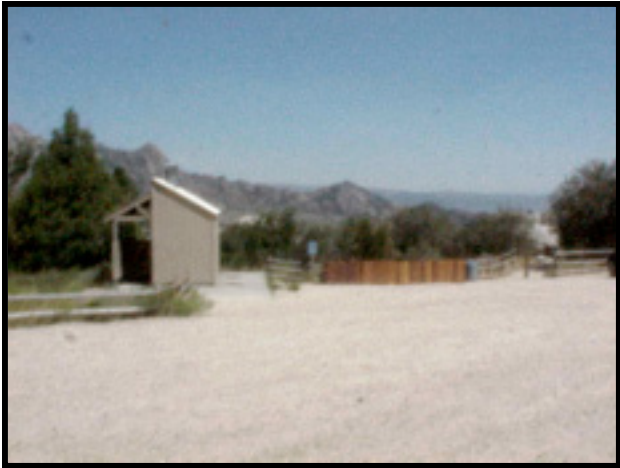
Before Replacement

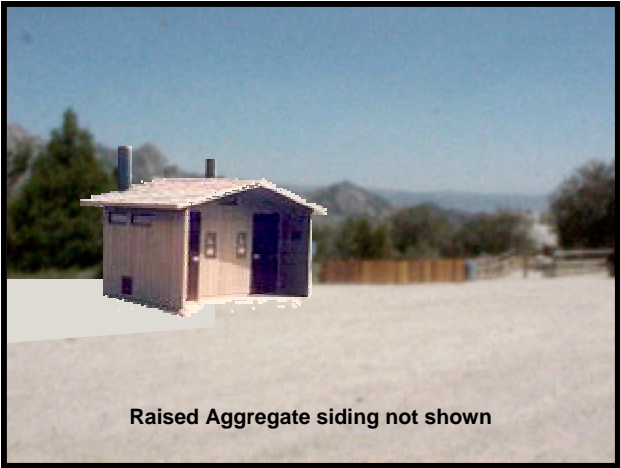
After Replacement
